Balloon Mishap in the Outback

Nuclear Compton Telescope Balloon Mishap

Senior Management ViTS Meeting

June 2012

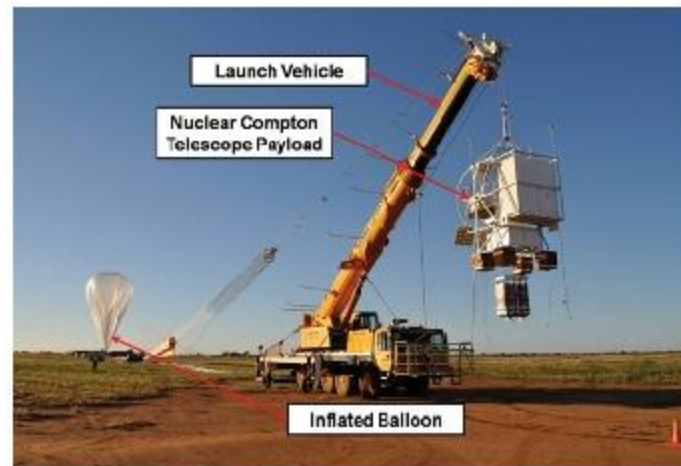
Figure 1: Launch configuration for the NCT during the day of the launch, preparing for release of balloon. Note the inflated balloon bubble.

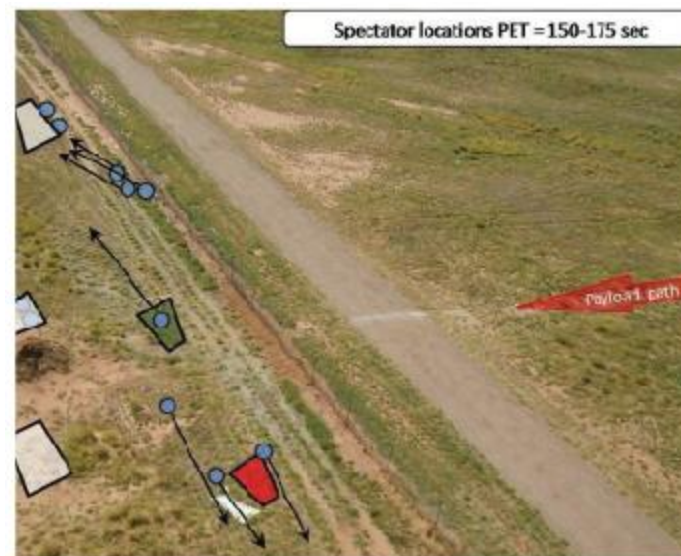
- This confusion and the final wind shift placed many spectators directly in the launch line.
- Some spectators parked their vehicles off road while others stood against the airport fence to watch and photograph the launch.

- Pre-launch flight safety assessments had only considered the ascent and over-flight phases, not the launch phase.
- The ground safety plan defined a hazard zone for balloon layout and launch, but it was unclear whether the hazard zone was fixed or moving with the launch vehicle.

Figure 2: Spectator locations (blue) in comparison with the payload path. Source: Mishap Investigation Board Report

- Development of a more stringent launch safety area in order to protect the safety of the public that also accounts for balloon launch vehicle maneuverability

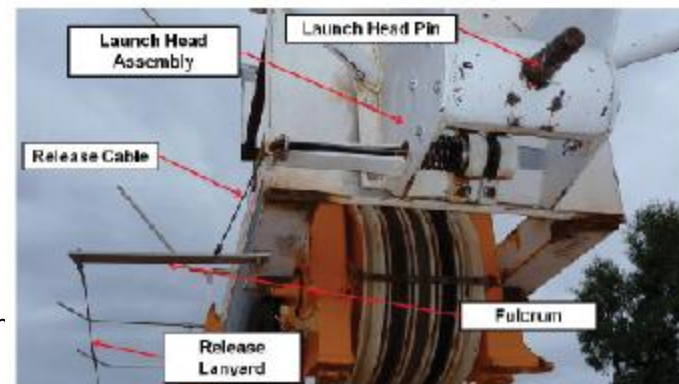
- After the launch vehicle regained traction and repositioned, the Launch Director attempted to launch the balloon, but after pulling the lanyard to release the pin, the balloon failed to release.

Figure 3: The launch head assembly showing release lanyard and pin. The release lanyard must be activated manually.

- The MIB recognized that the Program was not aware of hardware limitations that might give rise to a failure during a launch vehicle maneuver, or that the payload release system needed to be analyzed for launch limitations.

- Redesign of the launch head mechanism, which failed during the Australia aborted launch
 - Improvement of plans to better respond to mishaps and close calls with respect to balloon launch operations

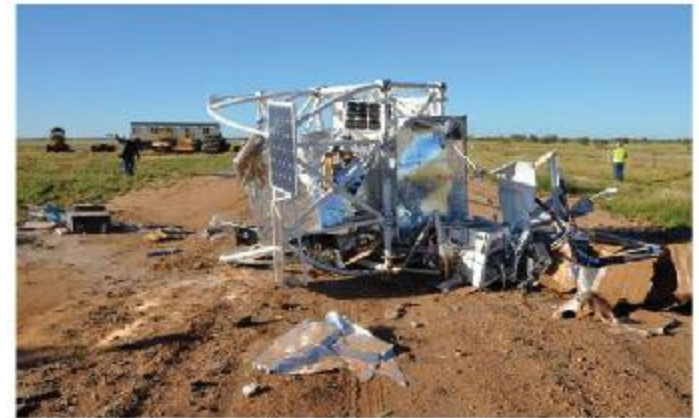
- Recognizing the unsafe proximity to the spectators and that the launch vehicle could not proceed any further, the Launch Director directed the launch vehicle to back away from the fence.
- Conditions made it unsafe to abort; by releasing the balloon without the payload, there was a possibility that the balloon train could fall on the spectators.
- The launch vehicle backed away from the fence, again losing traction in the soft ground. Intending to abort, the Launch Director attempted a left turn to move away from the spectators.
- The restraint cables failed under excessive side loading and the payload was inadvertently released.
- The payload was dragged along the ground through the fence and collided with spectator vehicles.
- Fortunately, the spectators evaded the incoming payload without injury.

Figure 4: NCT payload crash site; the NCT sustained major damage.
